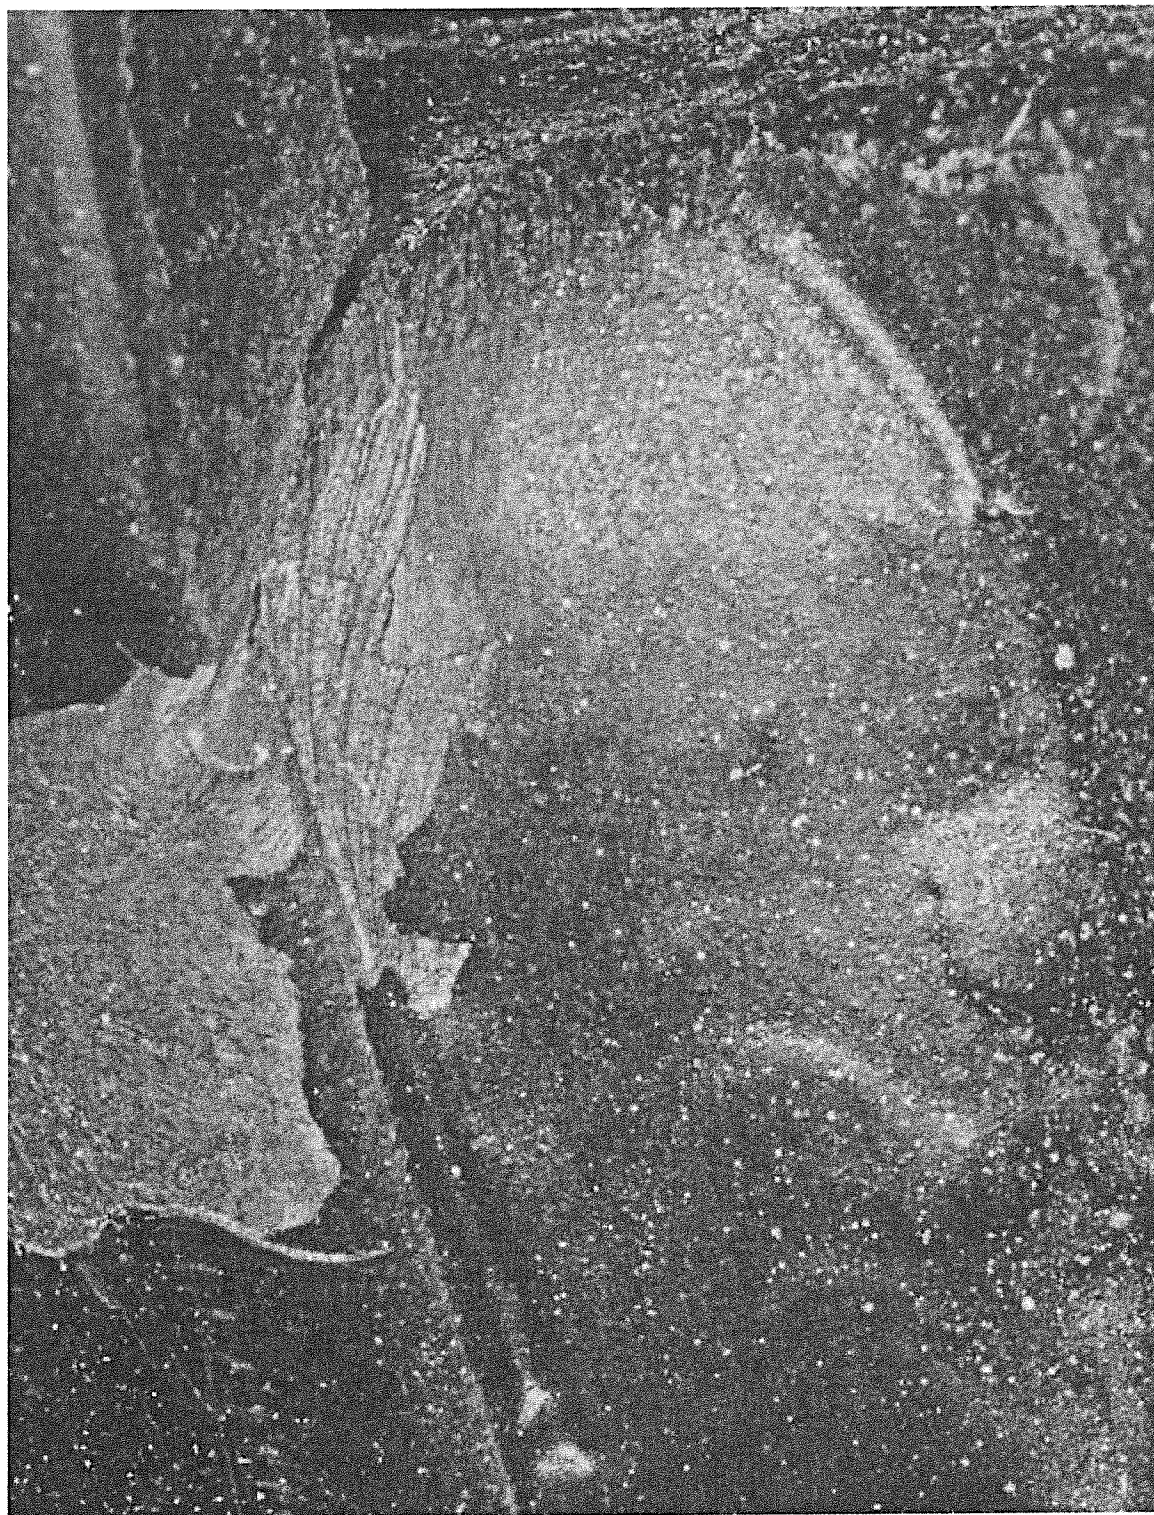
Figure 4. Picture showing the right-side of the steps that did not have the large crack that was on the left-side. It appears that the welding process utilizing a torch caused an ingress or groove (i.e. a smaller crack) in the link.
